Subjects: Dock and Sea Trials "RTA 1" Catamaran Passenger Ferry
Metal Shark Franklin, LA.

The following was observed during my visit of April 27, 2018

First Catamaran Ferry "RTA 1"

Two (2) 32.0 (m) X 7.7 (m) X 1.35(m)RTA Passenger Ferries

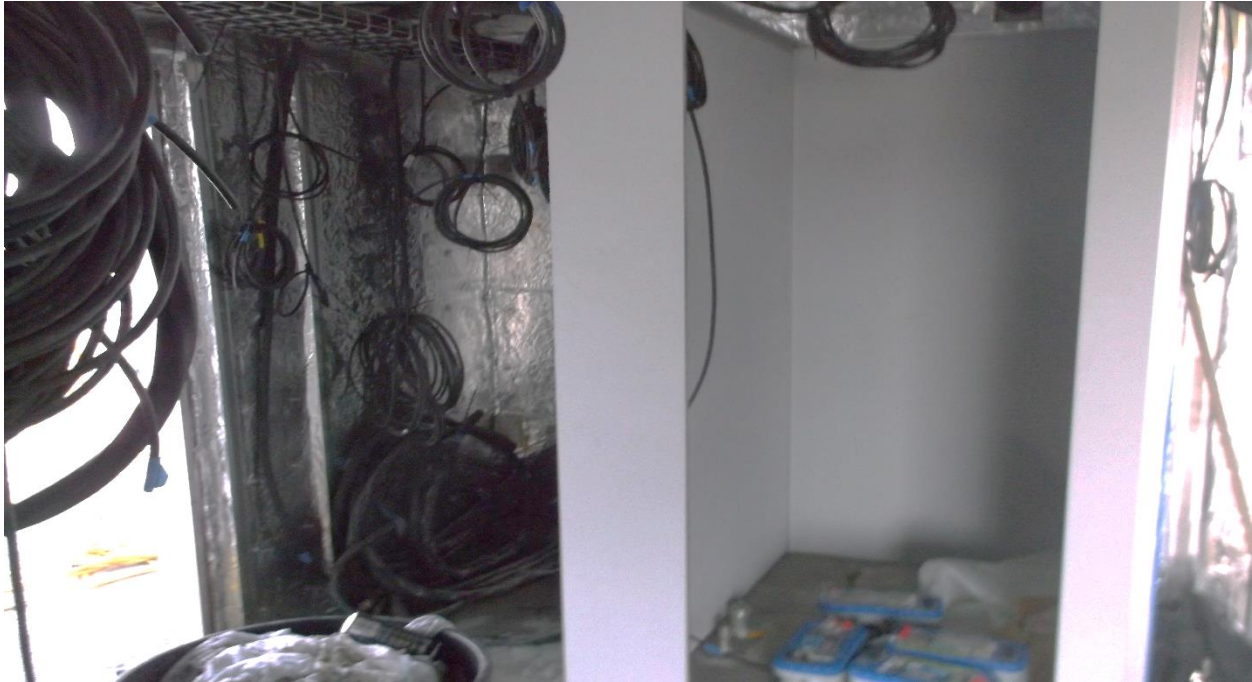
View of aft end jointer walls installed at electrical switchgear room and head (restroom)

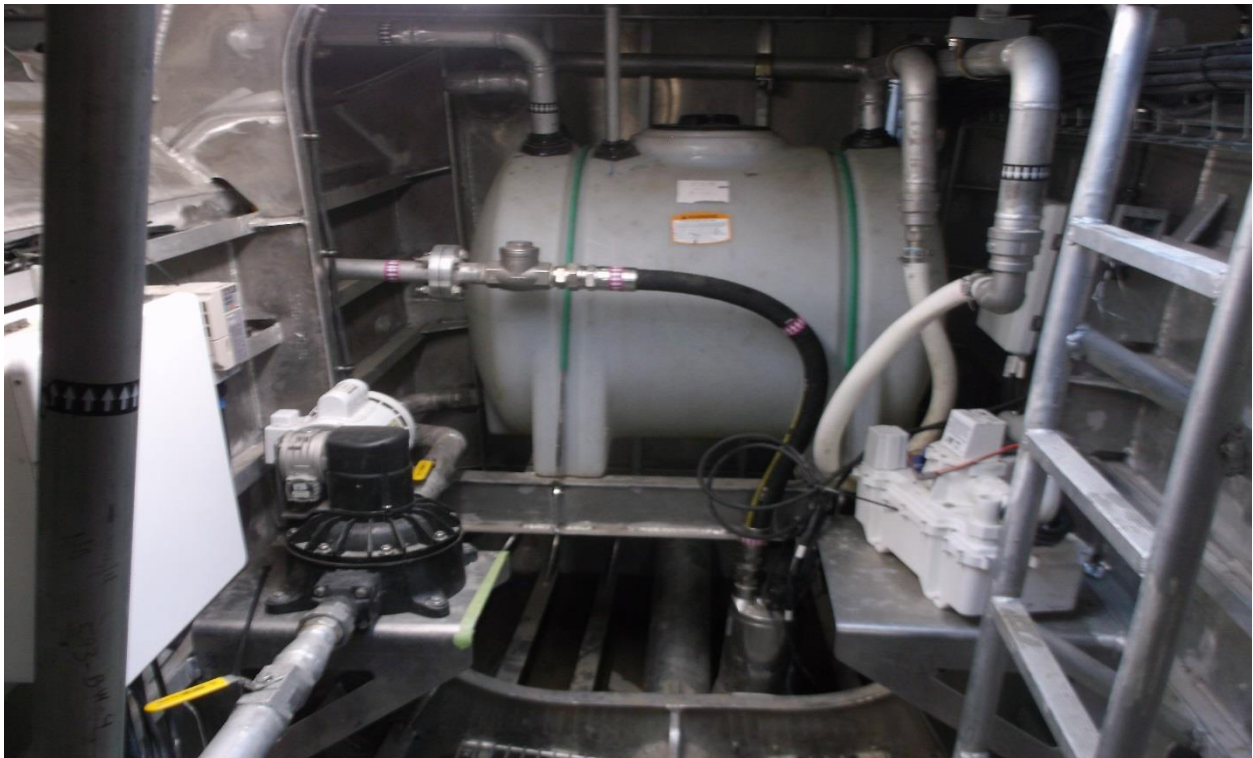
Forward view of above compartment with gray water tank and pumps having electrical and piping connections

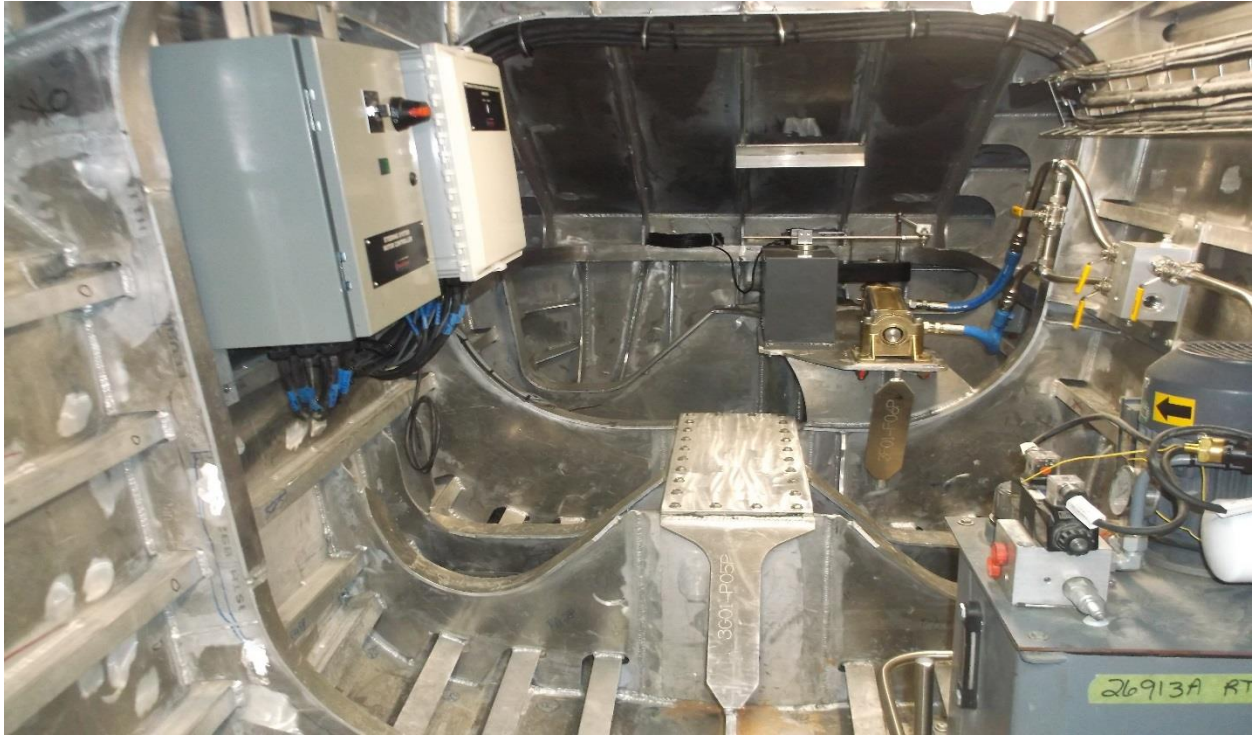
View of port no.5 steering compartment having control panels installed and wired into the system

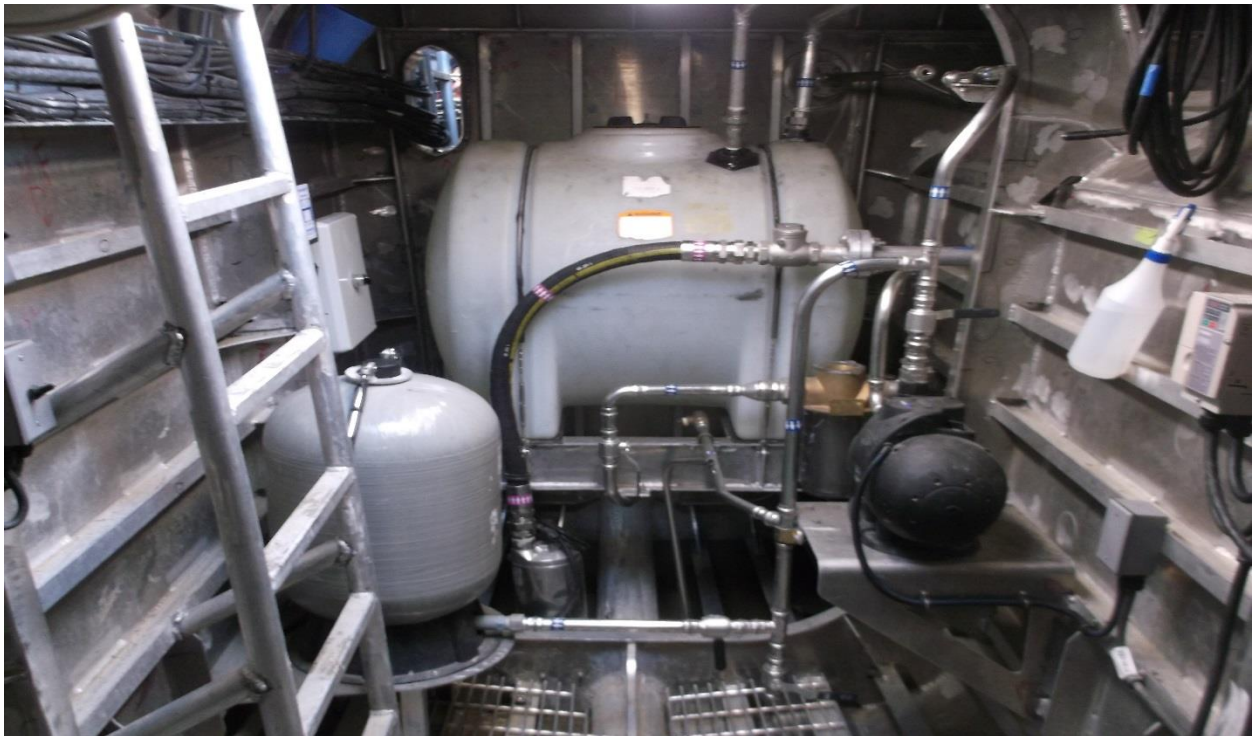
Forward view of above compartment having potable water piping and pump connected

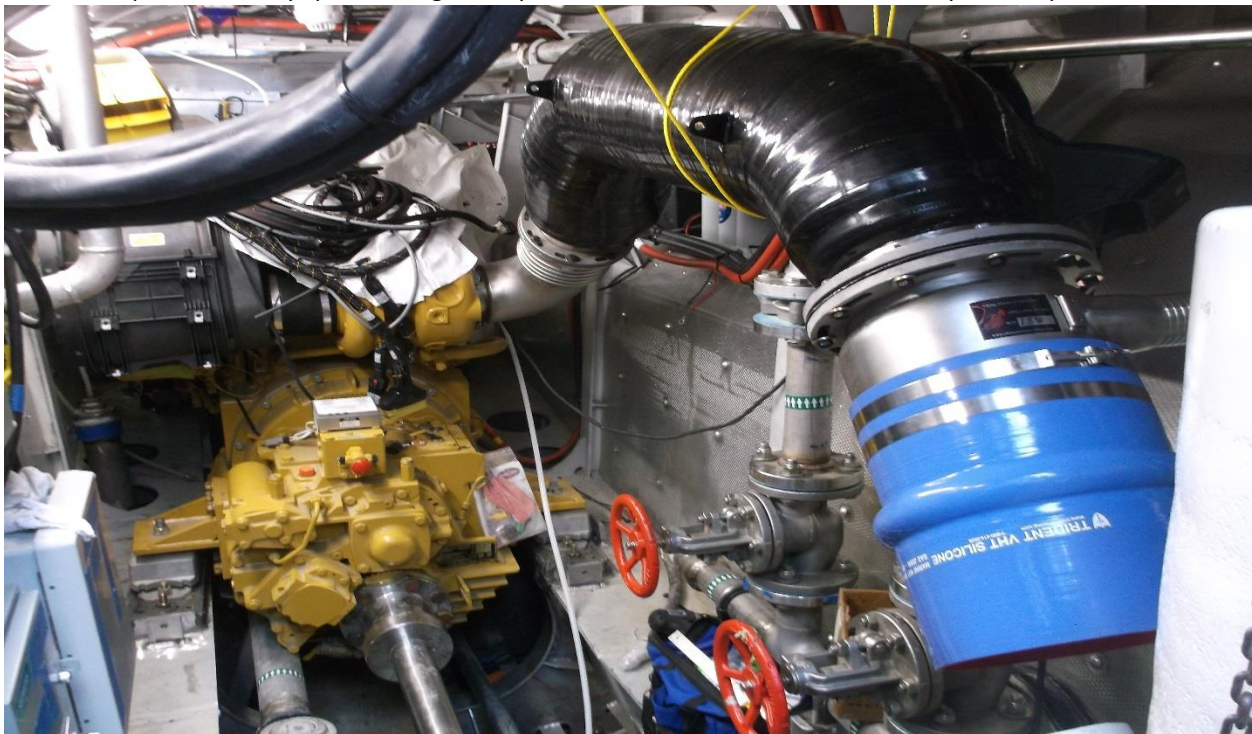
Inboard view of above photo with exhaust system installing

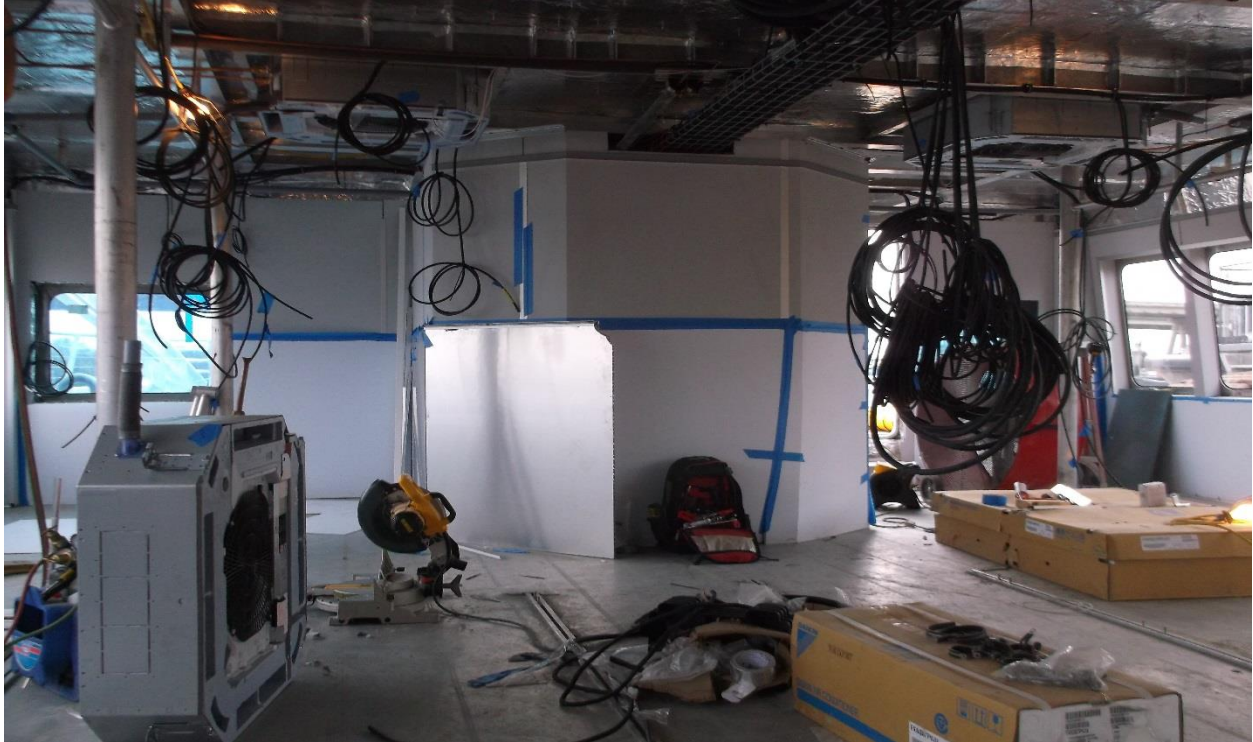
Forward view inside deckhouse having jointer walls for crew office and sheathing installed

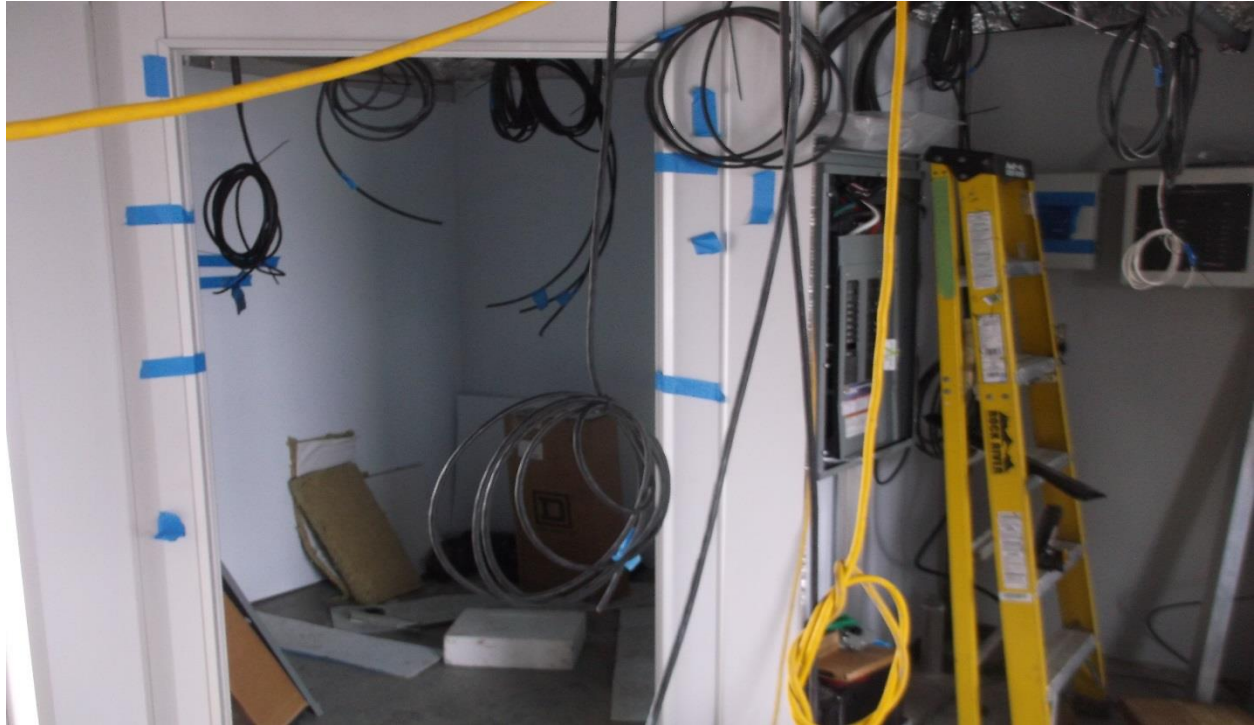
View of ADA head and secondary electrical room with circuit panels and cable drops

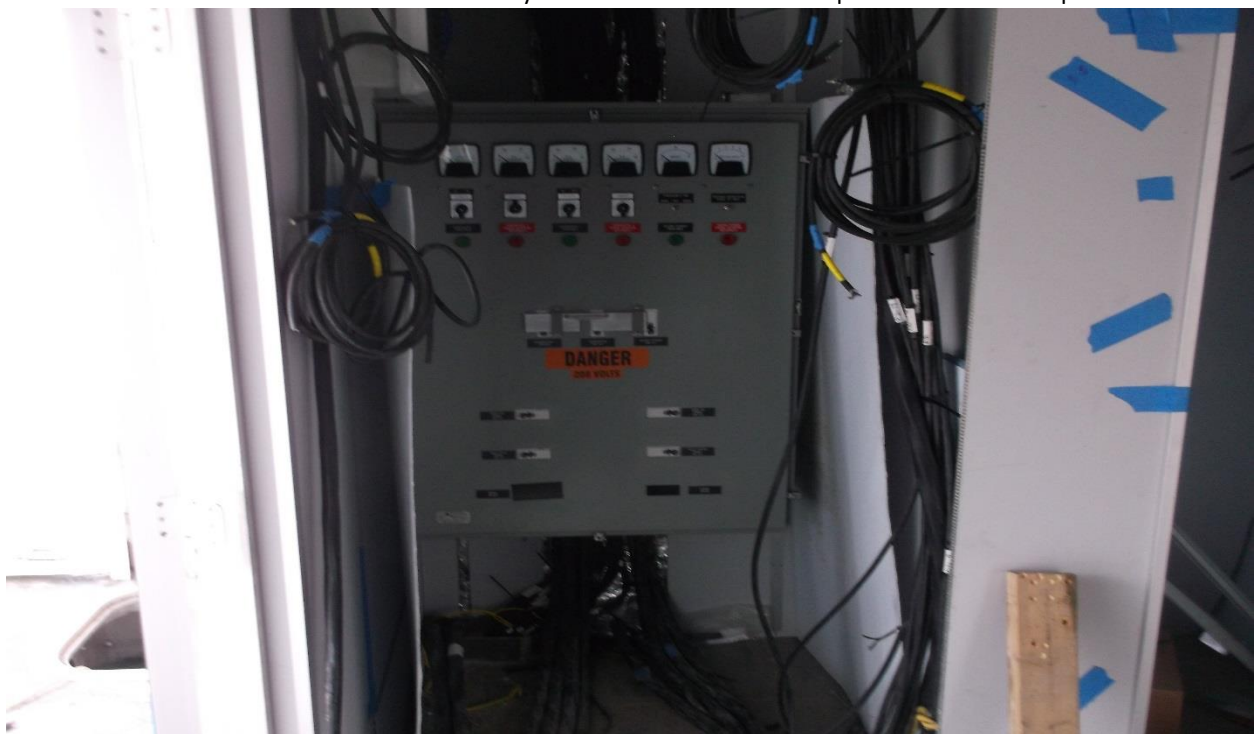
View of main power electrical switchgear installed

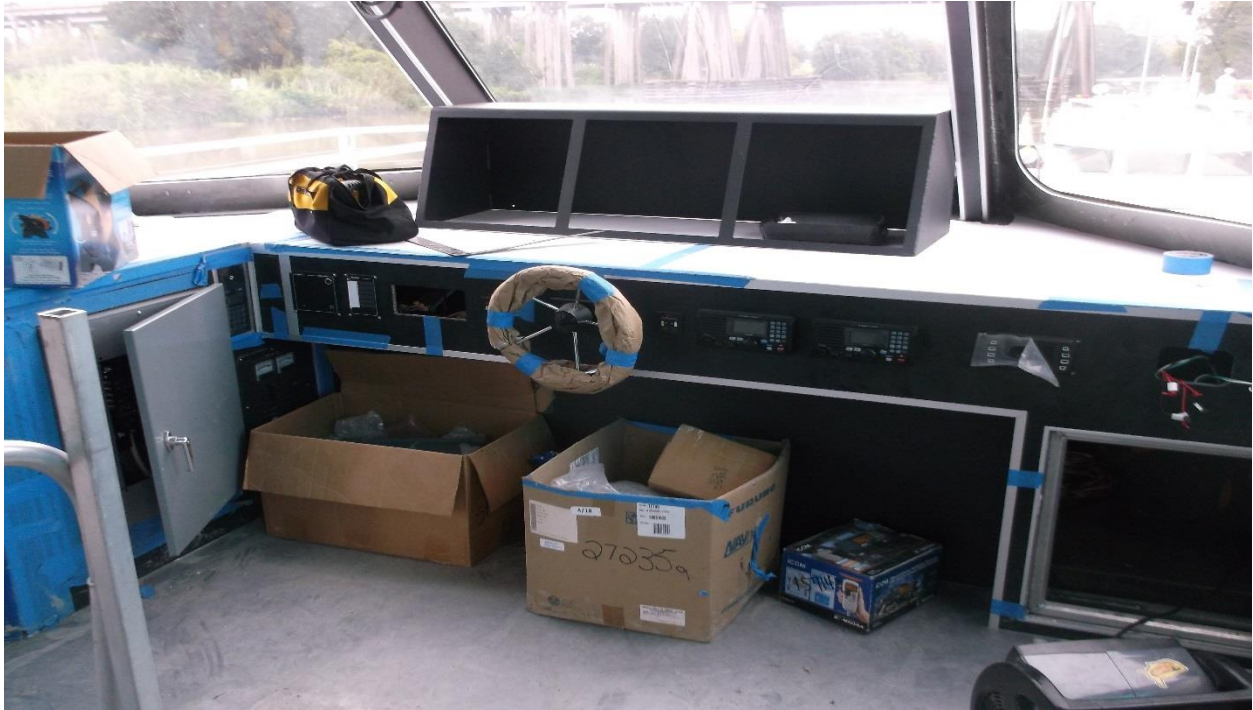
View of console with housing for monitors installed

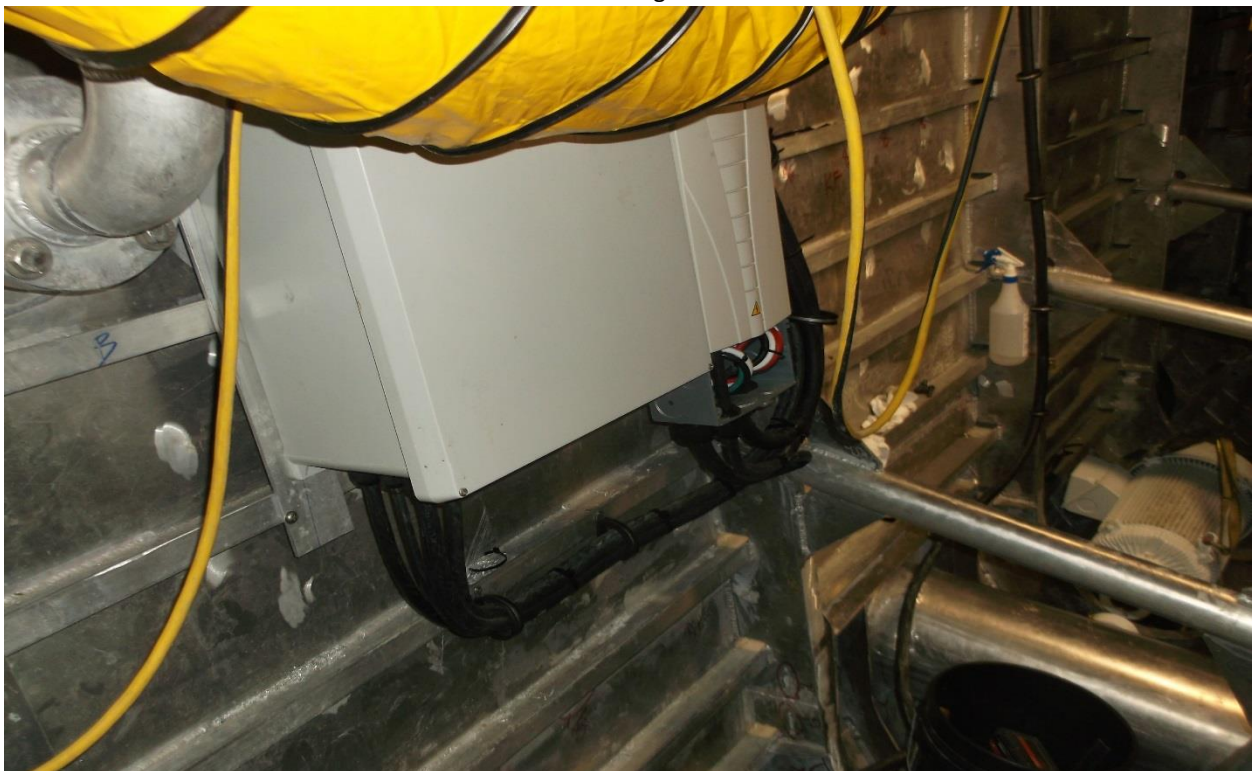
View inside no.2 starboard hull compartment having bow thruster motor and electrical control panel installed

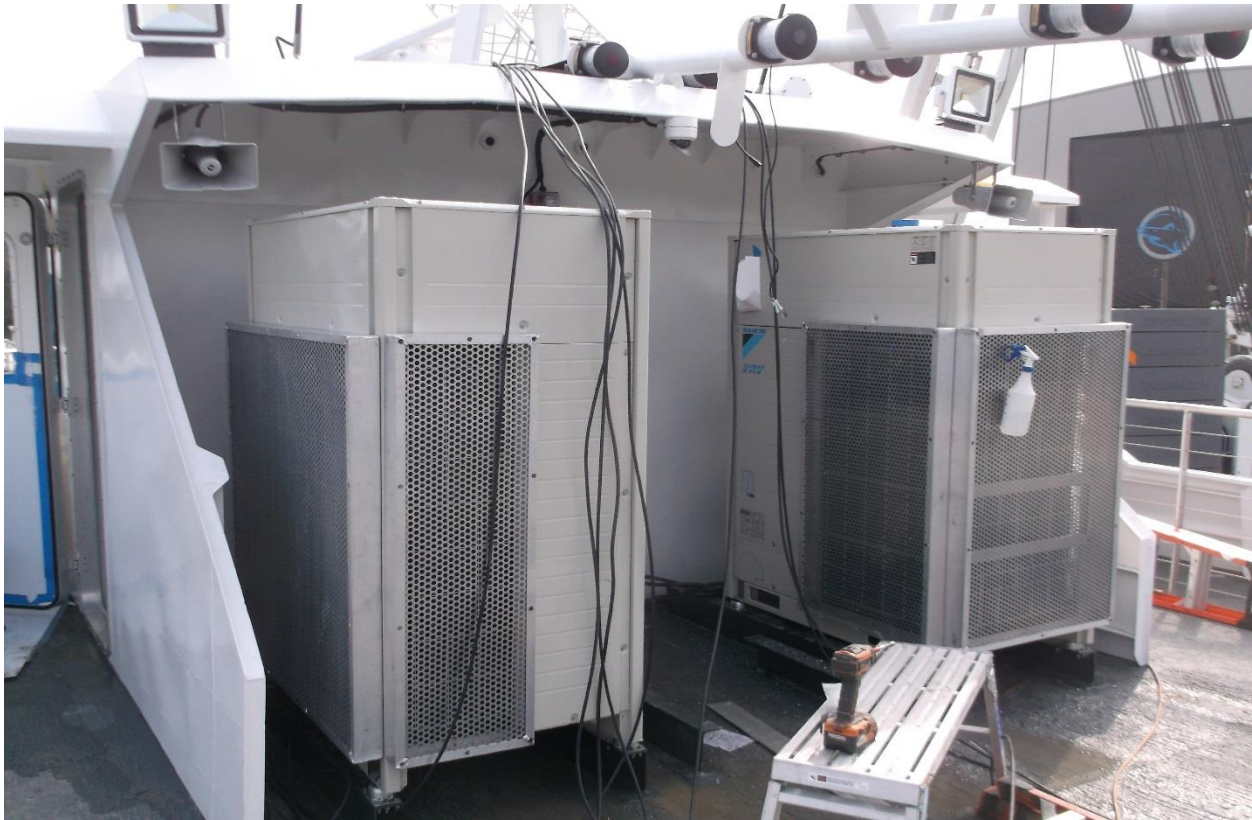
View of condenser units installed onto their foundation

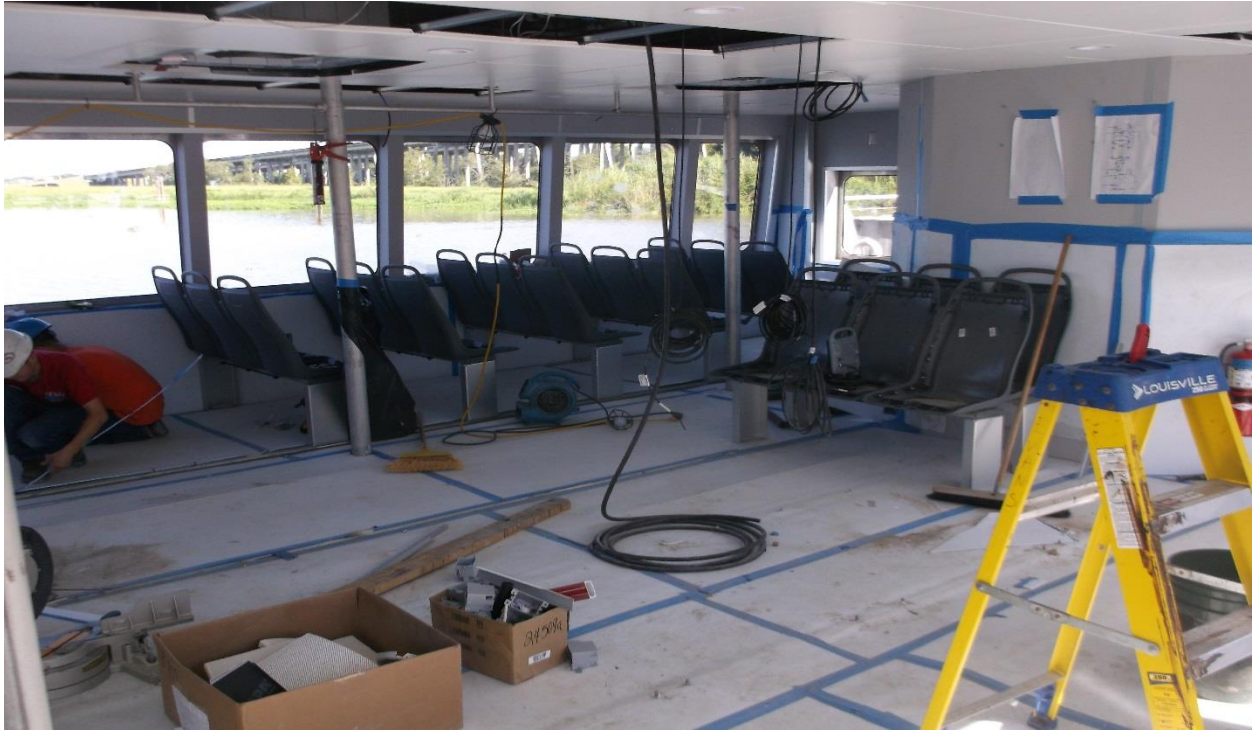
Deckhouse forward portside view with seating installing

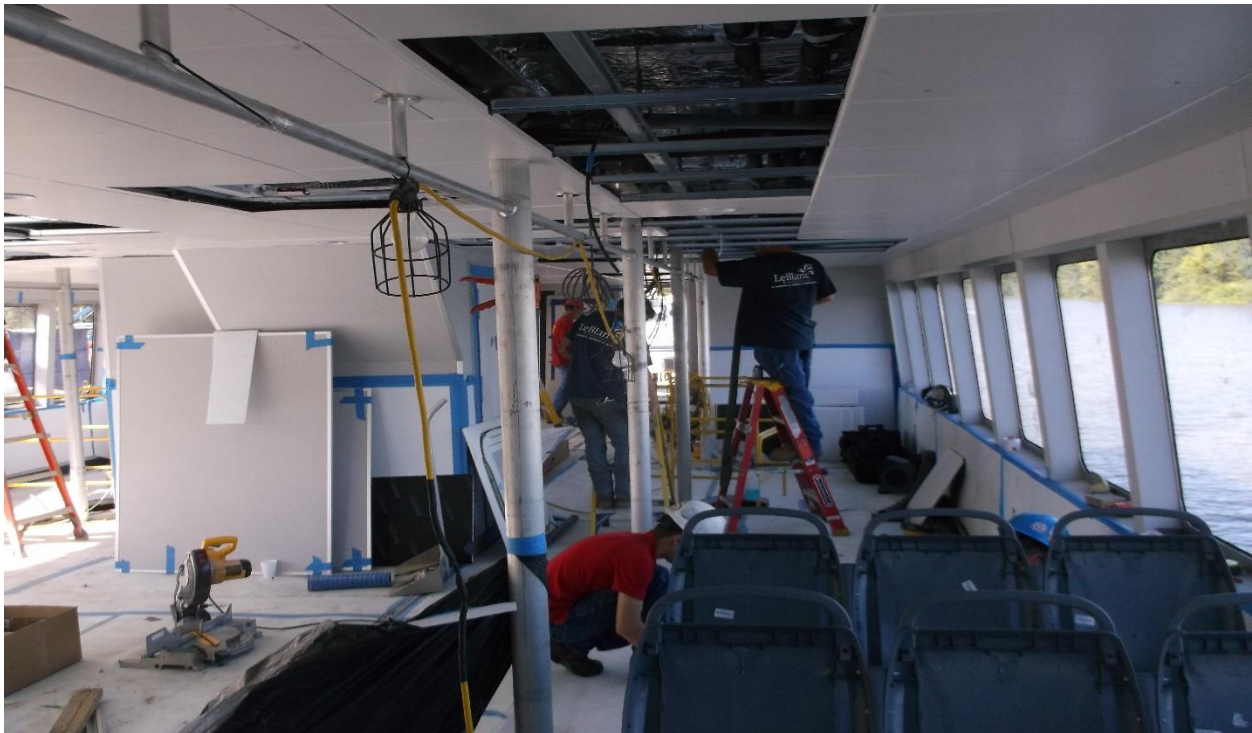
Aft portside view with workers installing insulation onto overhead HVAC condensation drain piping

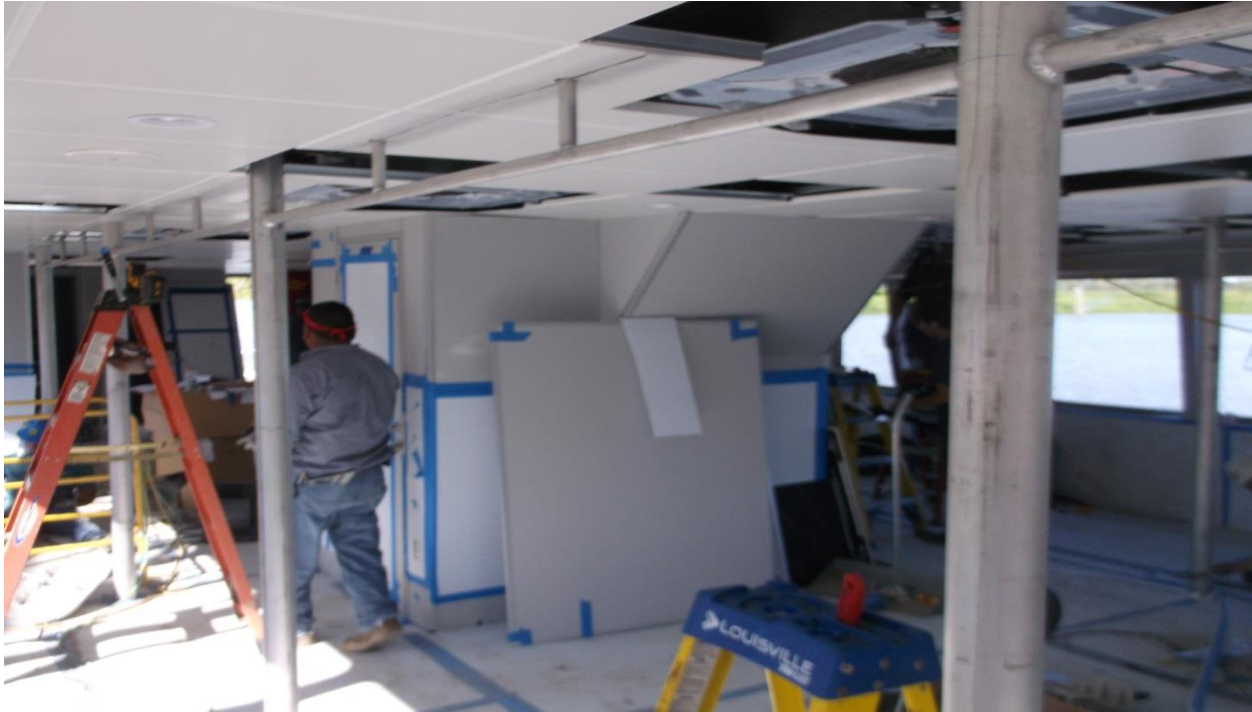
View aft centerline stairwell enclosure with workers installing ceiling tiles and trim molding

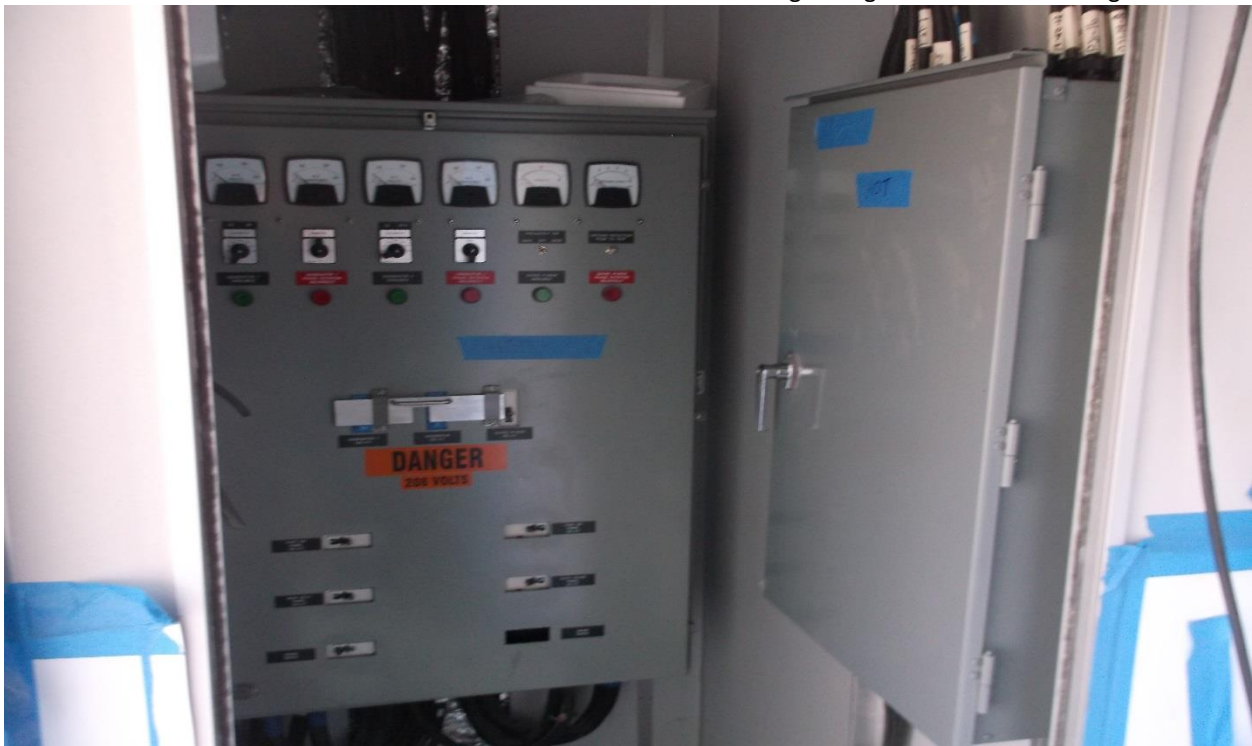
View inside electrical switchgear room having electrical cabling installed

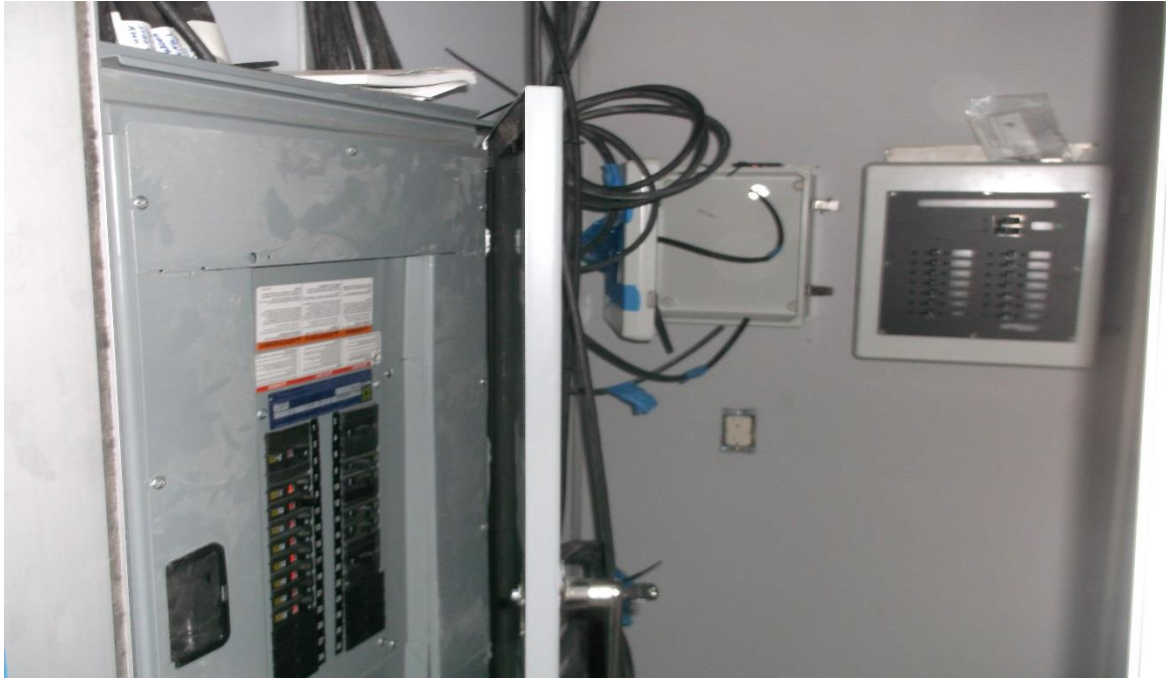
Secondary electrical room with machinery monitoring panels placed for wiring installation

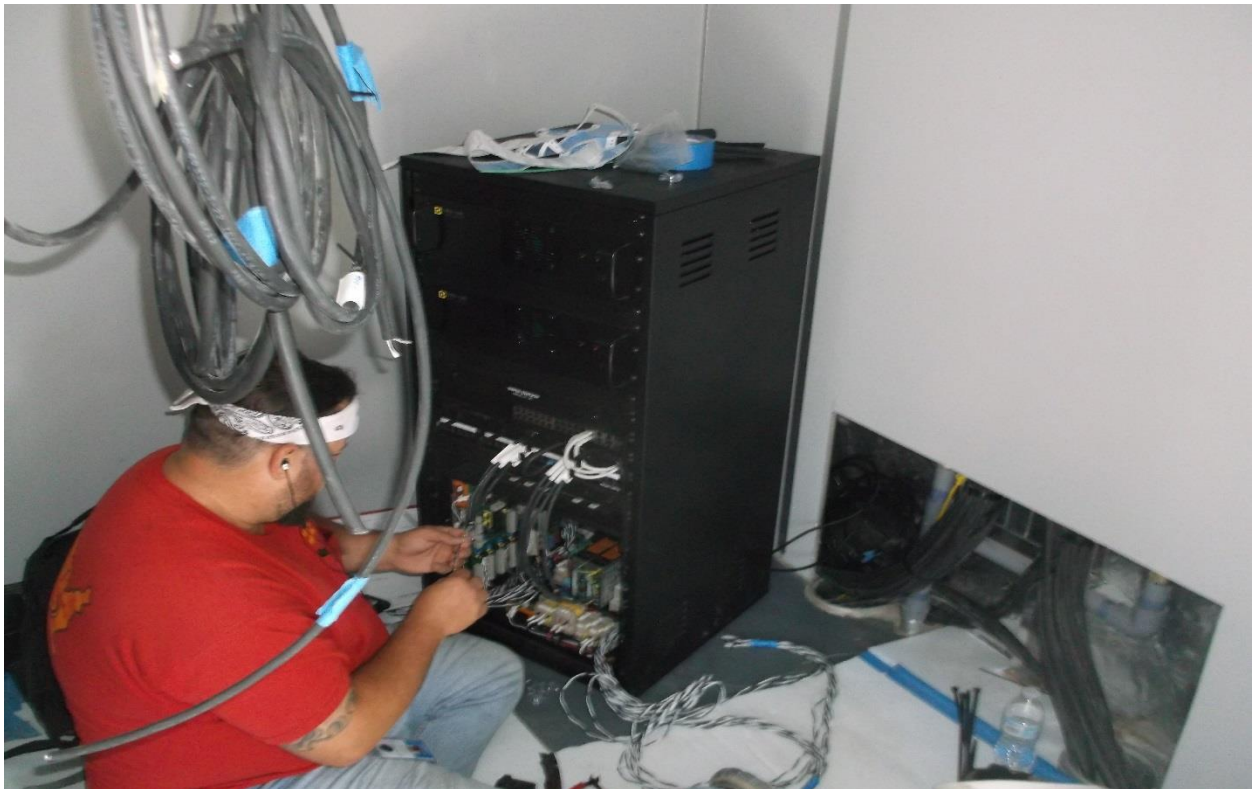
View inside crew office with wiring connections being made to the video main frame

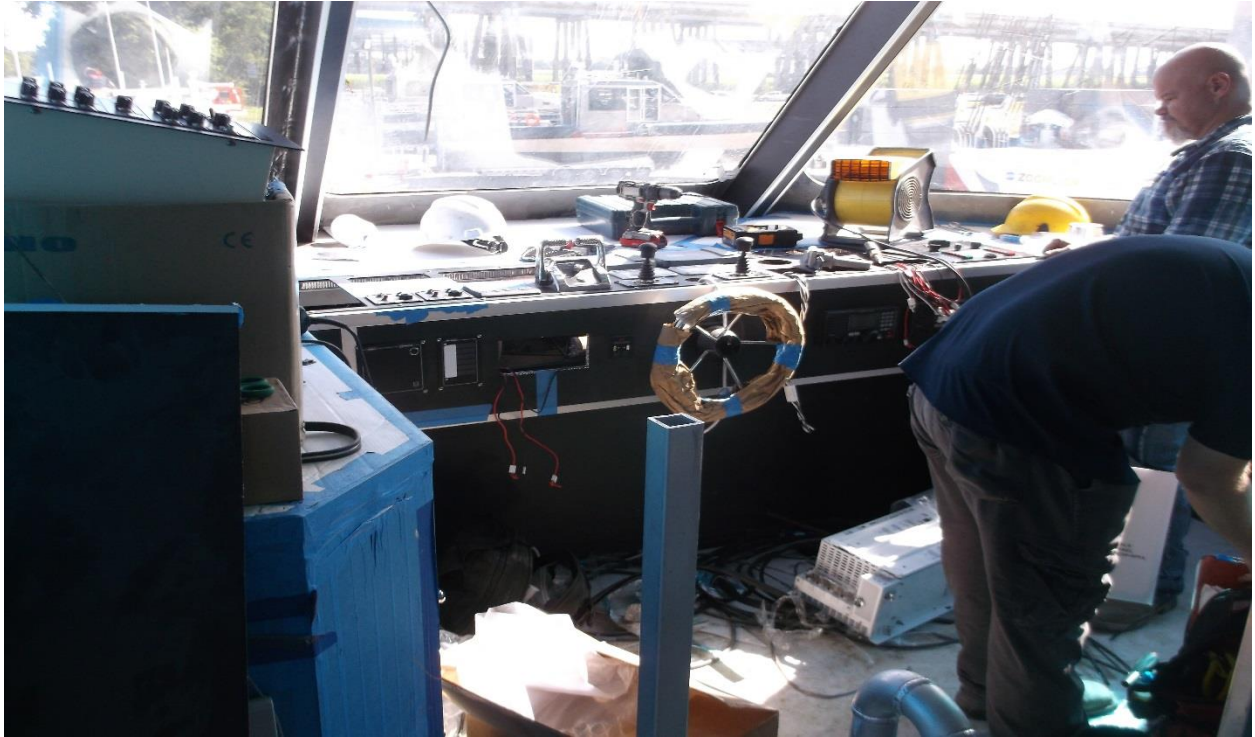
Views of Pilothouse console having vessel operational equipment installed

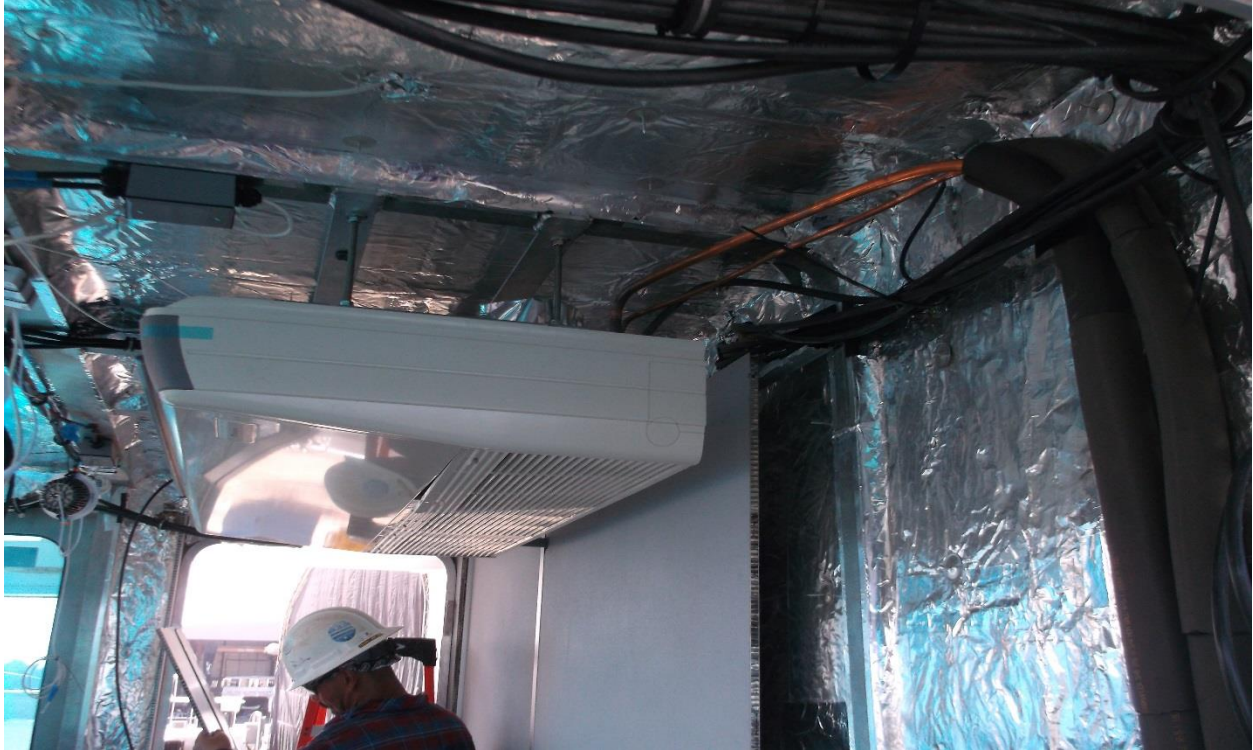
View of HVAC evaporator unit installed inside pilothouse

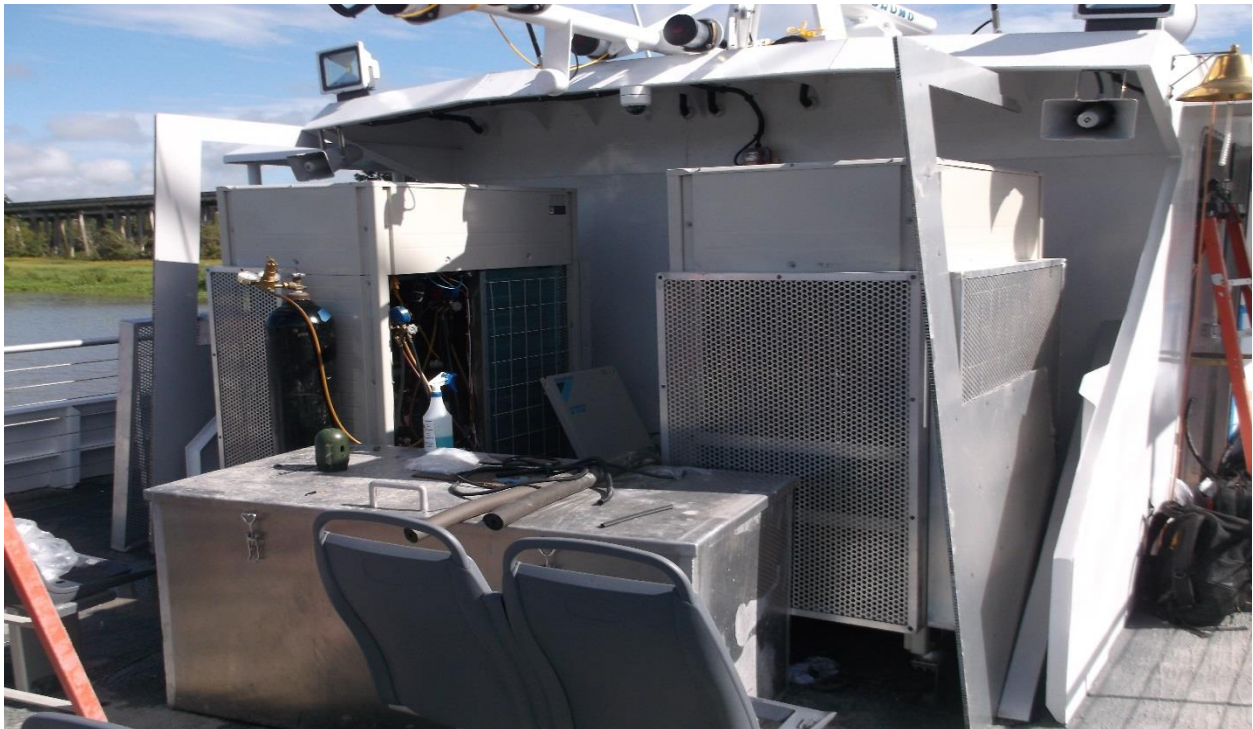
HVAC condenser units having refrigerant piping connected with nitrogen purge/pressure test in progress

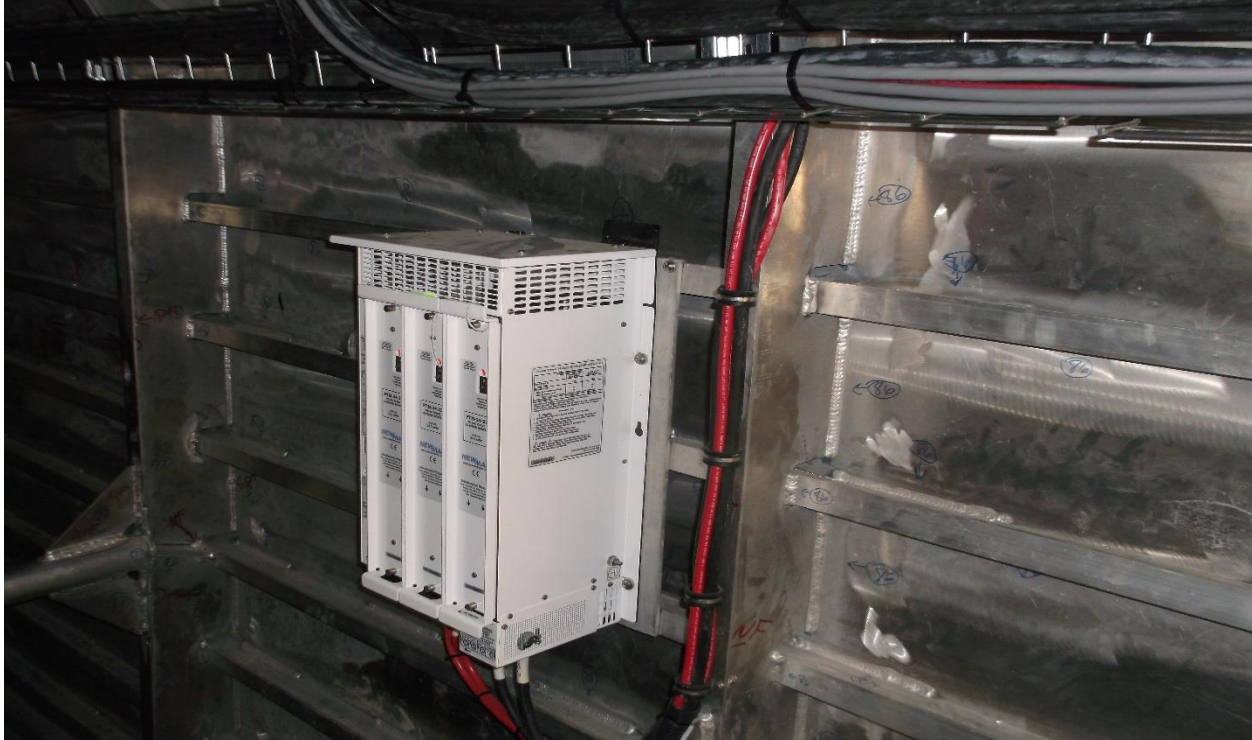
No.3 port hull compartment having the battery charger for machinery space wired into the system

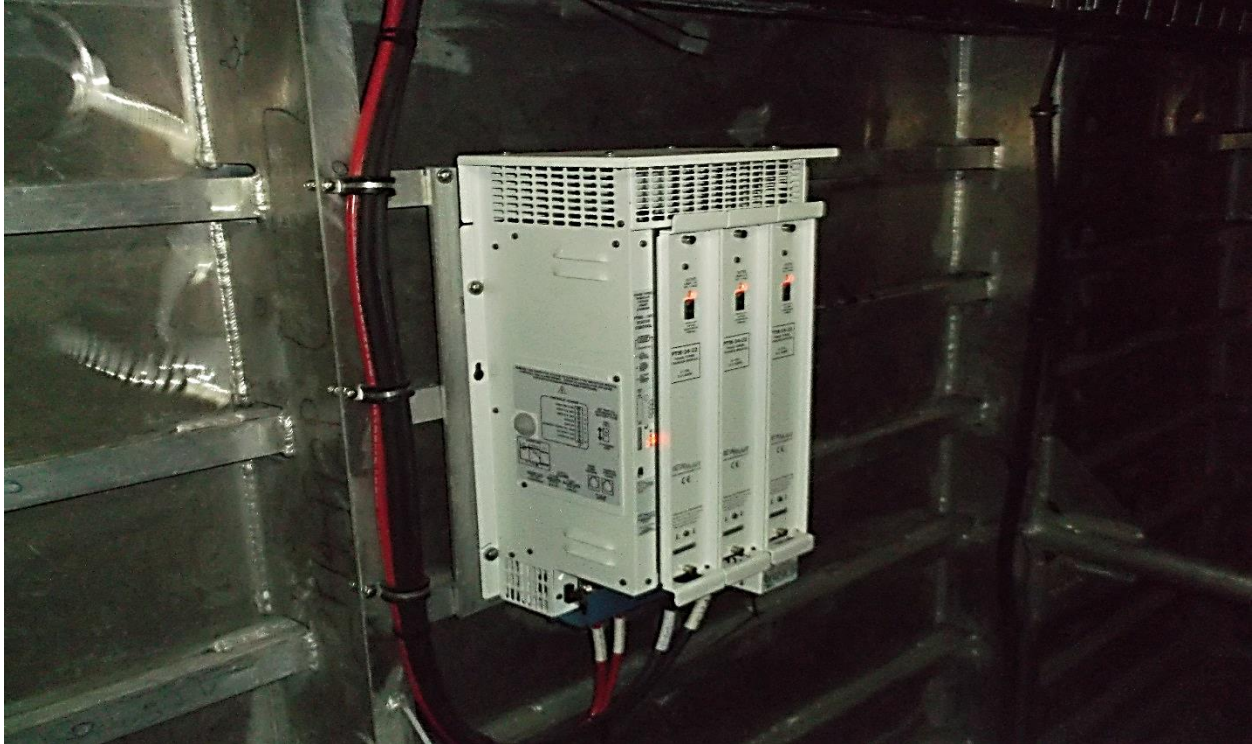
No.4 starboard hull compartment with machinery space battery charger wired into system

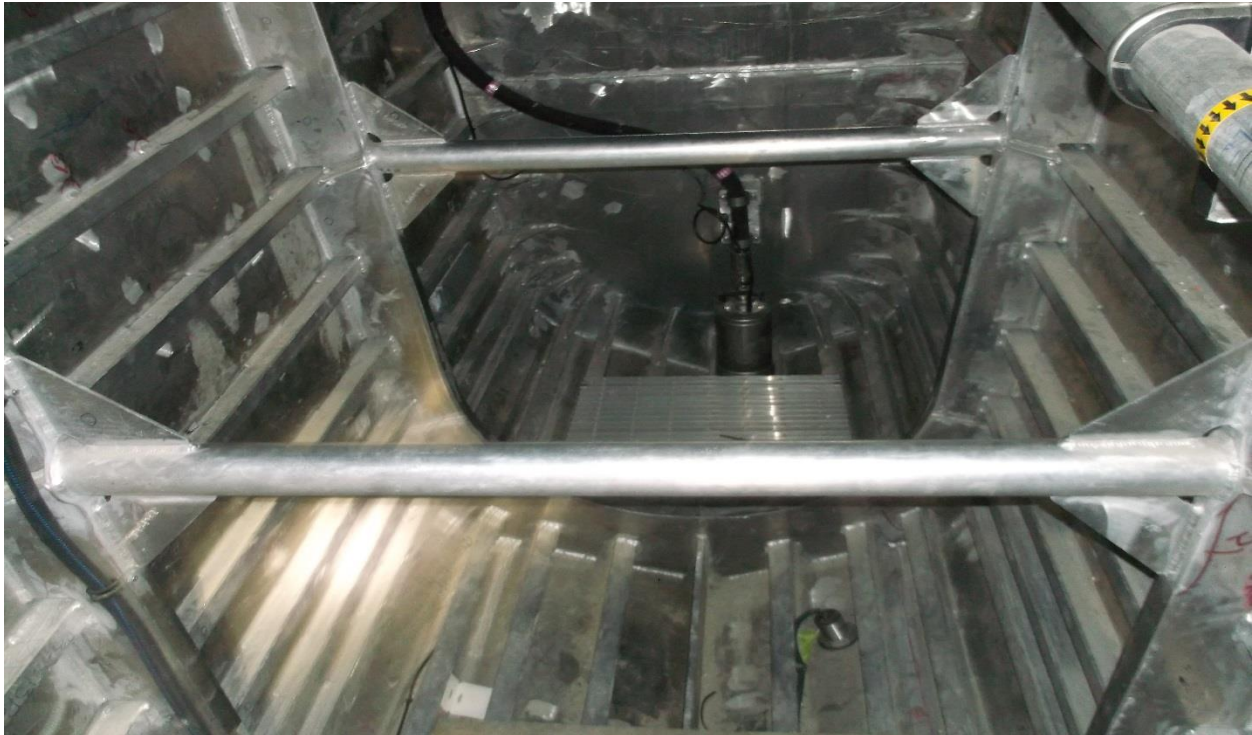
View looking aft of above compartment having bilge pump and transducer wired into system
